This brewery needed a solution for the multitude of failures on its metal roof. The galvanized metal was wearing down, the roof was absorbing massive heat from the sun which was negatively affecting the building's cooling costs.

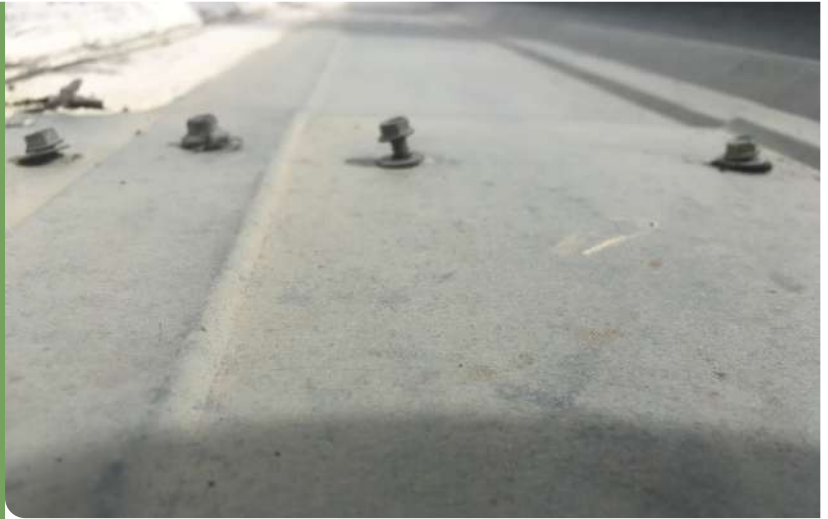
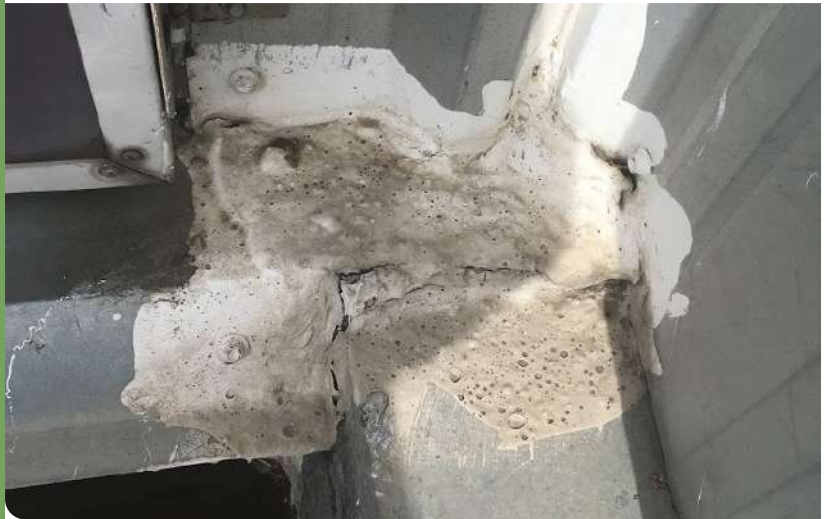
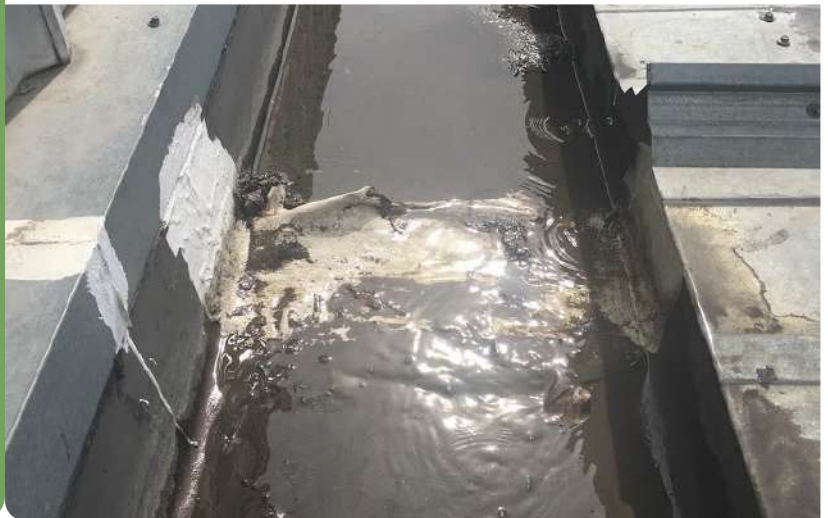
The fasteners were backed out, the neoprene washers had deteriorated, gutter liners were peeling and ice-damming had worn-away at all of the joint and termination caulking. They had tried to solve the leaks by hiring numerous reputable roofers, yet year after year the roof continued to spill water into their brewery.

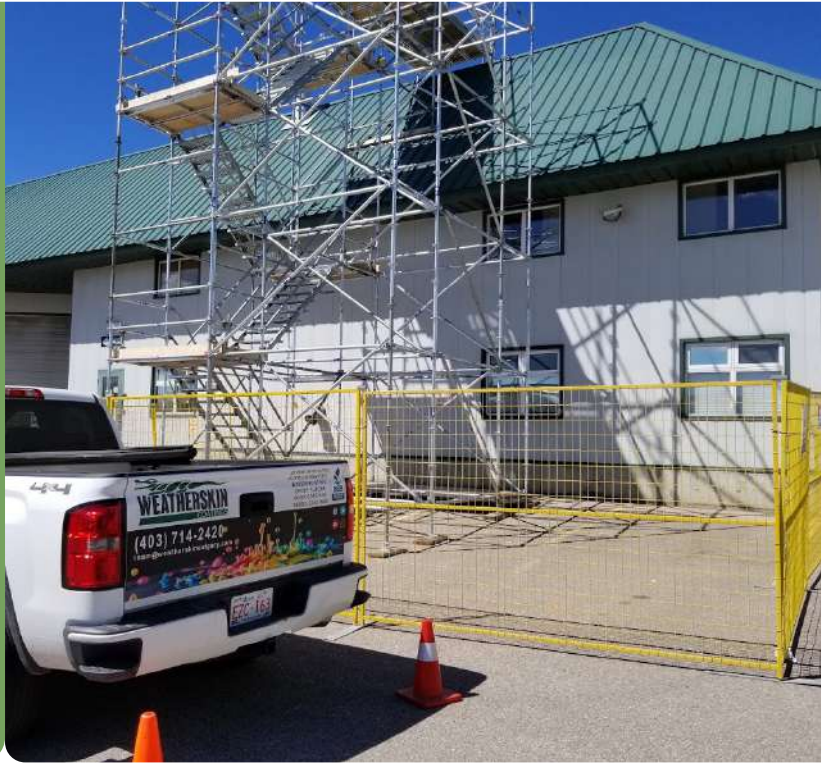
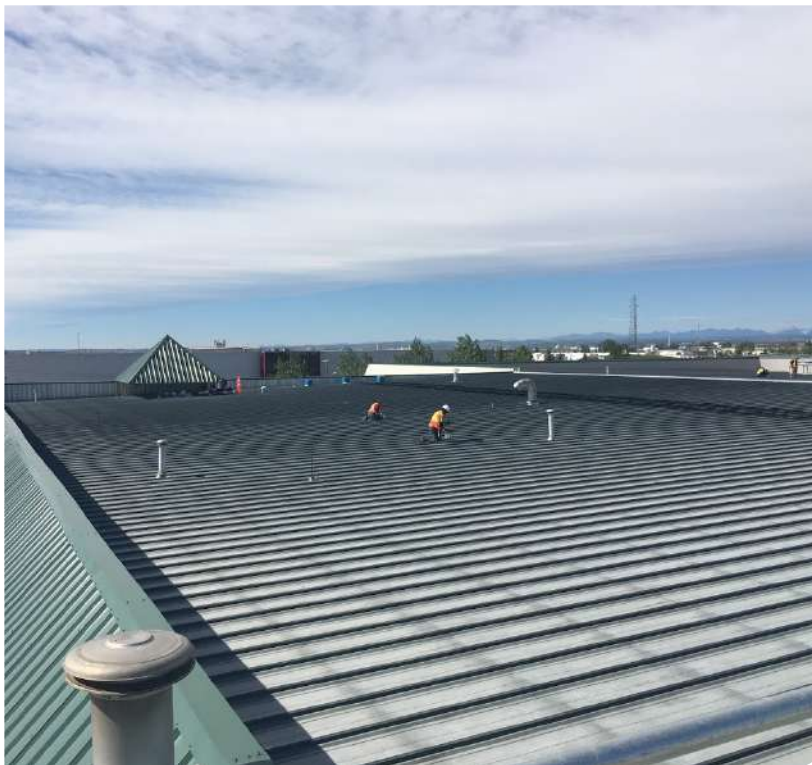
First our experienced team inspected every square inch of the roof, marking all the potential fail points with fluorescent tape so they wouldn't be missed during the first steps of application.

Weatherskin first had to be able to easily access the roof. It is always helpful to be friends with a scaffold company because within 24 hours the site access was set-up and material was delivered to the site.

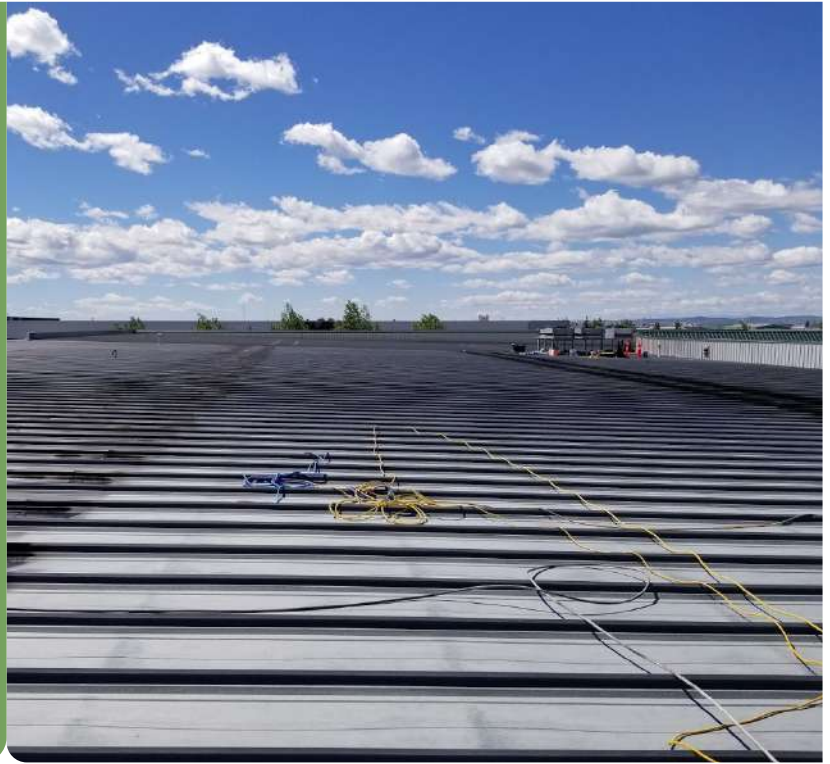
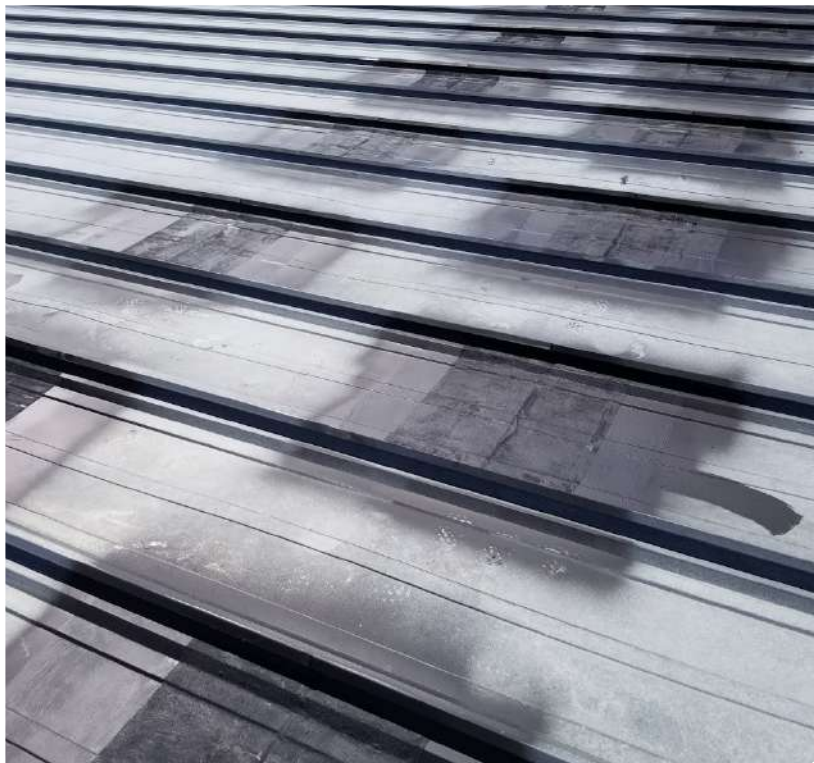
After the roof had been prepped and sanded, the spray equipment was brought onsite and all problem areas, especially the seams, were sprayed black. This ensured these areas would not be missed and would get the extra layers of protection over the main body of the roof.

The seams needed special care. After being re-caulked with polyurethane to bring them back to their original state, Weatherskin applied high tensile, extremely flexible fabric over-top of these areas, ensuring that as the roof expands and contracts no cracking would occur in the final coating on top of these troublesome areas.

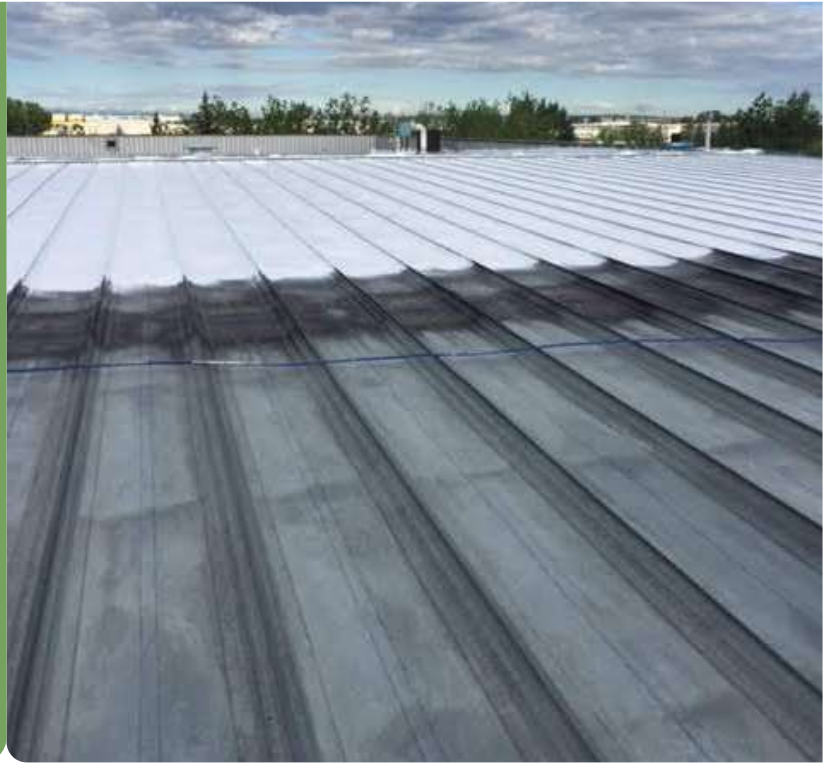
The first coat of white Weatherskin coating was applied to tie the project together. At this time, the gutters were re-lined and other terminations were incorporated into the roof with polyurethane and fabric. As usual, special attention was given to the vertical walls, caps, h-vac units, terminations and vents. Ponding often occurs against these obstructions as they block the flow of water and can create massive ice and snow build-ups.

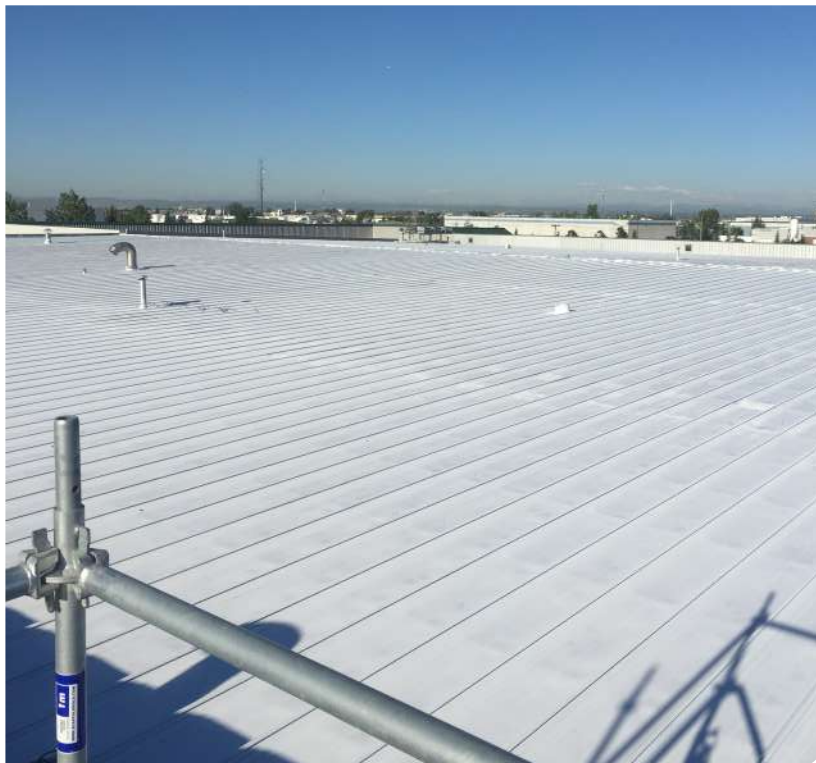
As the project came to a close, the roof looked brand-new at a fraction of the cost of doing a full replacement. The white blanket makes it extremely easy to re-service the roof. Any future deficiencies can be spotted from far away and only take minutes to repair versus days of trying to trace a problem leak back to the source.
