## **ROOFING CASE STUDY - PUBLIC SCHOOL**

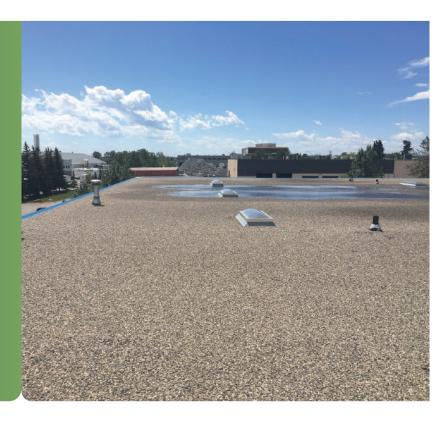
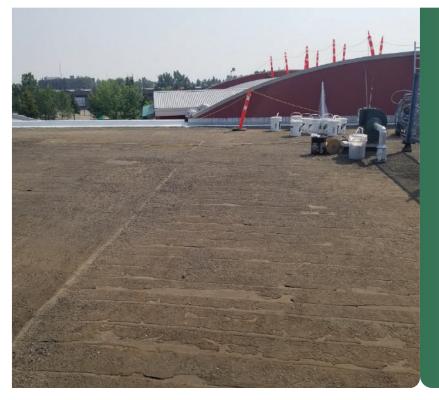
The stress load from the gravel and the constant leaking due to ponding water and poorly protected scuppers/terminations signified a complete tear-off which would be an enormous cost and inconvenience to a school with year-round operations.

Weatherskin came to the rescue, removing as much of the gravel as possible. The remaining embedded gravel would stay behind. First, all the terminations, scuppers and perimeters were properly sealed and protected with high tensile fabric interlaced into the first 2 coats of the Weatherskin membrane

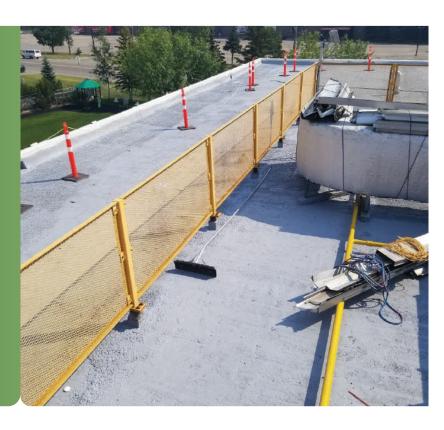
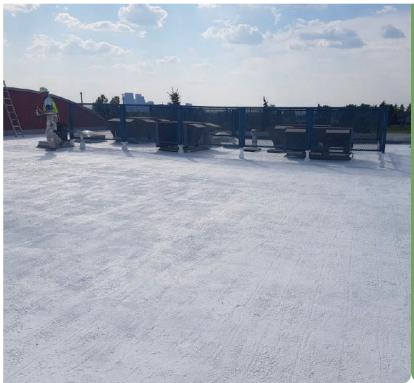
Strands of fibreglass and sand were mixed into the 2 base coats of Weatherskin on the roofs main body. This created a structural layer that tied the remaining gravel into the body of the coating to keep it from puncturing the top-coats.

Any seams in the tar paper that have the potential to become trouble areas or deficiencies later were sprayed first to ensure they would be completely sealed by the basecoats. Even a single void in the coating can cause issues later, but they are easy to spot when you're applying light grey over a black substrate.

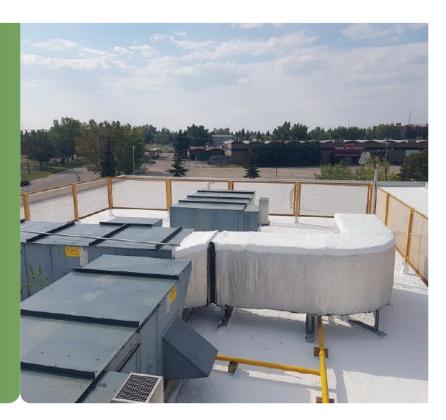
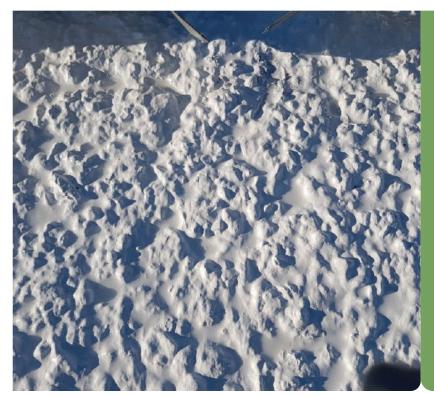
Even the fence posts and support blocks for the gas-lines and h-vac's get incorporated into the system, to ensure that even under 2 feet of snow the roof stays protected. Roof terminations are always treated with a special amount of care, as they are common culprits for leaking. The final coats are white, reflecting the UV and heat which will save on cooling costs over time.

Even where the embedded gravel was still prominent, the end coating of Weatherskin has immersed it under a tough blanket that can be walked on and easily serviced without causing any problems. The Weatherskin team will re-visit this roof every year it is warrantied to protect the client and their investment.
