The existing epoxy product was extremely weak and never meant for this application. Due to poorly prepped floors and poor adhesion, after only 5 months the floor was failing everywhere. Anywhere that heat transfer occurred like under warm tires, or where chemicals were spilt, the floor had instantly yellowed.

We didn't want to put the client through the same painful process twice, so we asked only for the weekend to get the floor blasted, patched, primed and sealed with 2 coats of Weatherskin interior epoxy and a Polyaspartic top-coat. Everything had to be removed yet again from the shop so that our team could get to work.

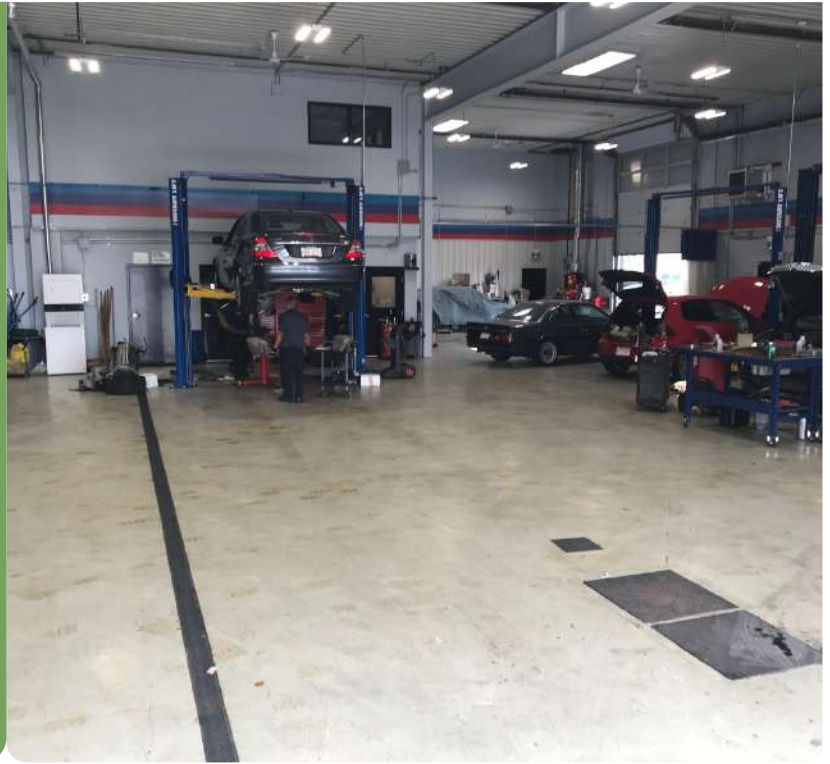
Cracks, bubbling and peeling were occurring around every floor termination. The worst part was that the former contractor had shut down operations for 2 entire weeks to get this product to cure.

They couldn't even pressure wash the floor without the coating peeling.

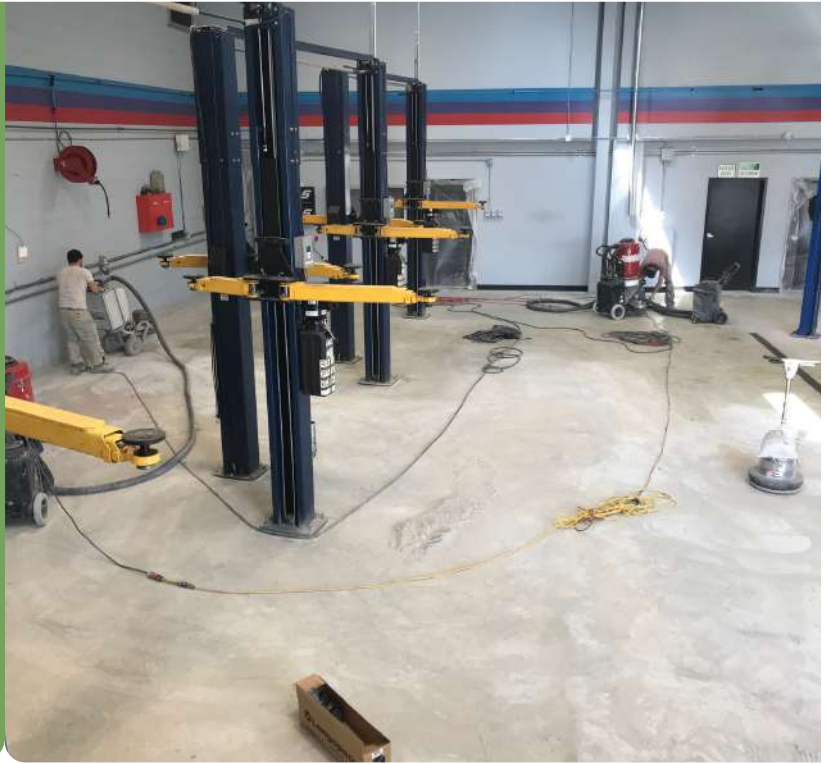
Multiple sanders, shot-blasters, grinders and vacuums were put to heavy use over the first evening and straight into early Saturday morning.

All the failed product had to be removed and discarded and the floor's surface needed to be properly scored.

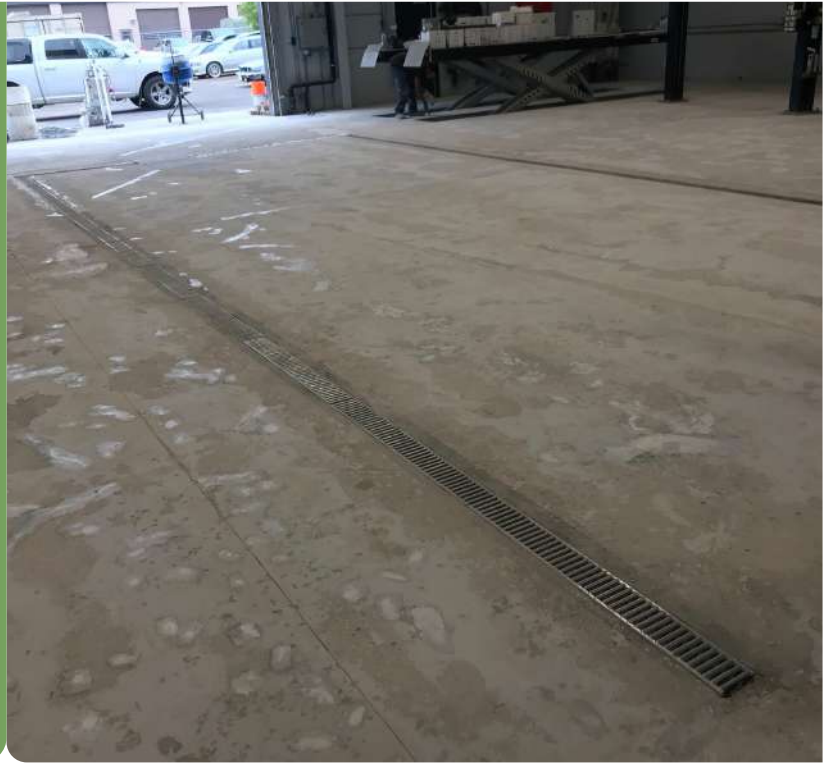
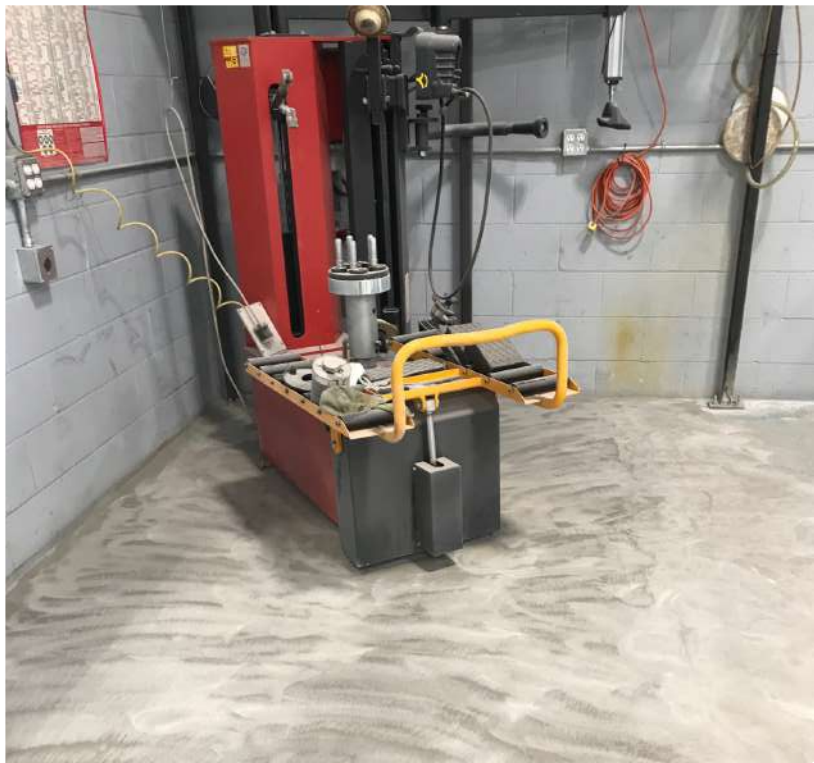
Hundreds of small fail points that were never addressed by the former contractor needed to be mended so that the result would be a smooth surfaced floor, without low spots where liquids could pool. This special attention to detail produces a floor that is much easier to maintain in the end.

A properly prepped concrete pad should almost resemble polished steel. Every speck of dust must be meticulously vacuumed off the floor. Small debris is the number one offender in an imperfect floor finish. The primer coat will be applied very thin, allowing the epoxy primer to permeate the concrete. If this coat is applied too thick, proper absorption into the concrete isn't achieved and proper adhesion may not be achieved.

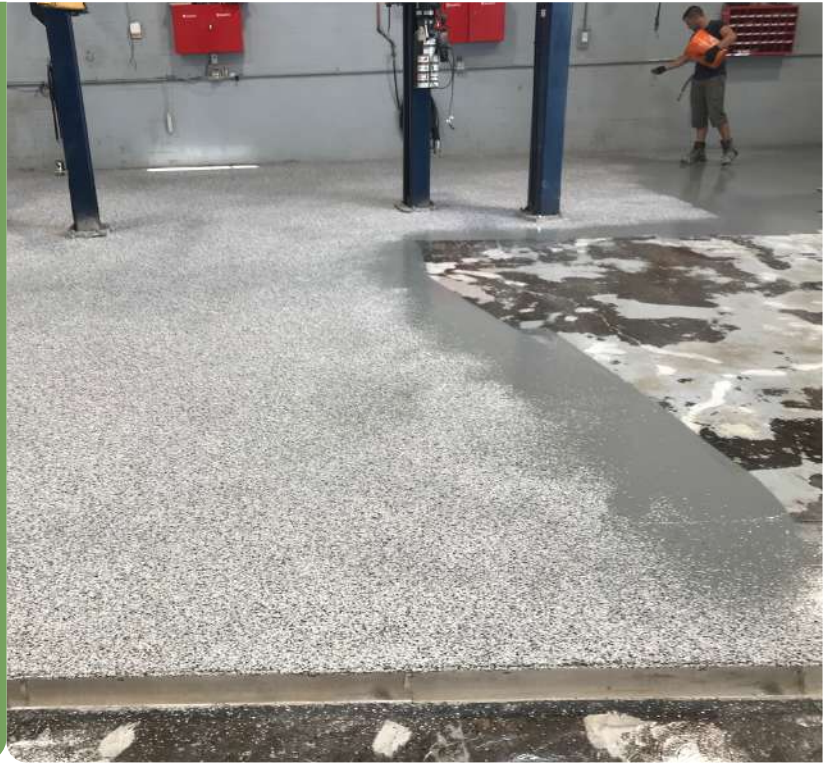
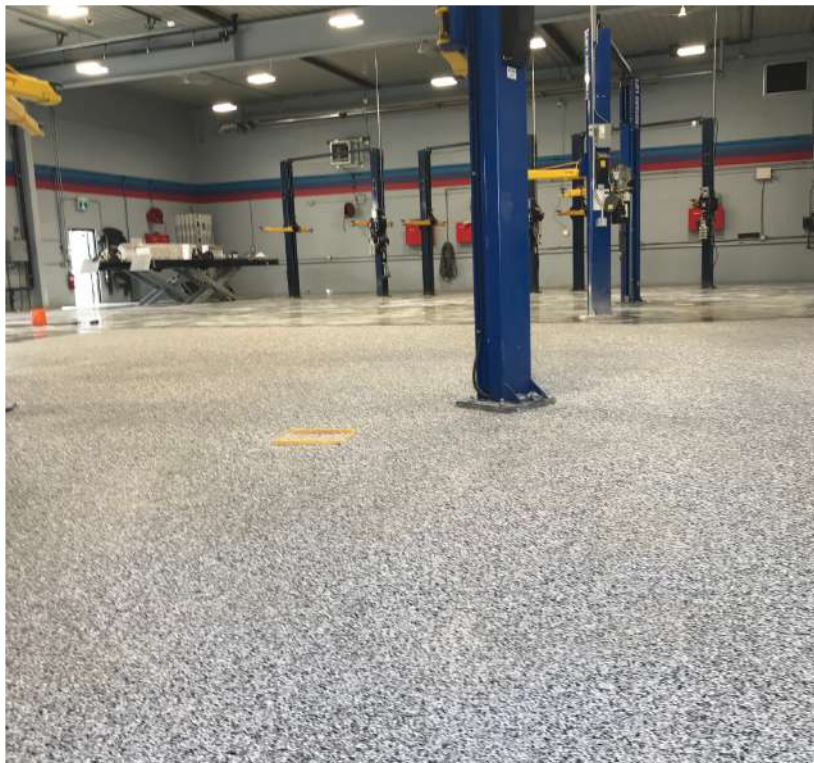
We are careful not to put down more epoxy than we can properly deal with at one time. Because of the fast curing nature of the product once it is activated, you want to make sure you don't get ahead of yourself. Having separate individuals mixing product, applying the broadcast-coat and dispersing the flakes is the way to go.

Section by section the floor comes together. The team rarely attempts more than 800 square feet at one time. It's always recommended to go heavy on the flakes versus going to light to ensure you get proper coverage. The excess can be swept and vacuumed once the coating has cured.

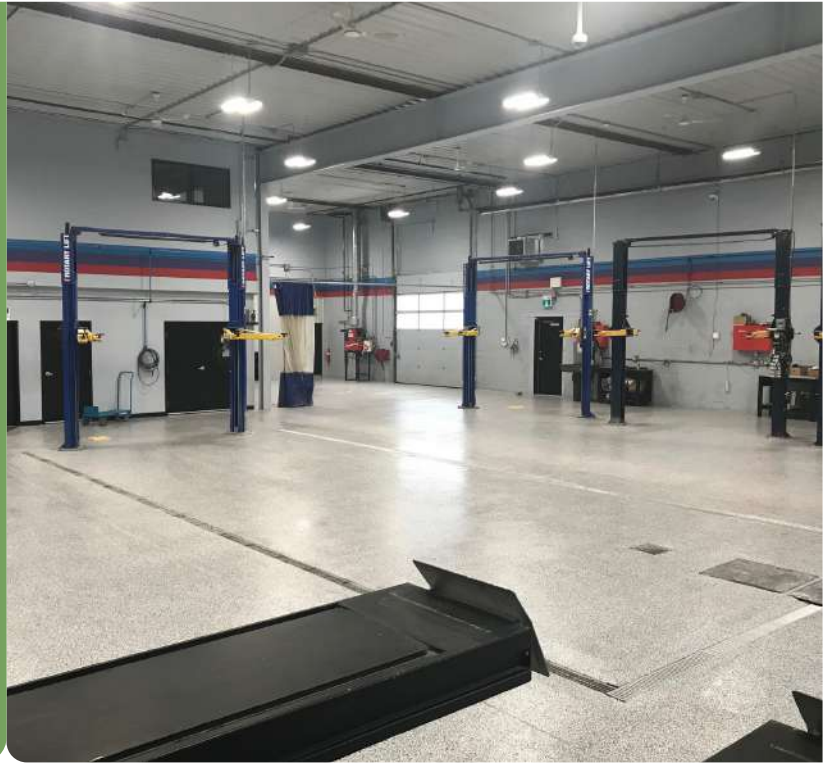
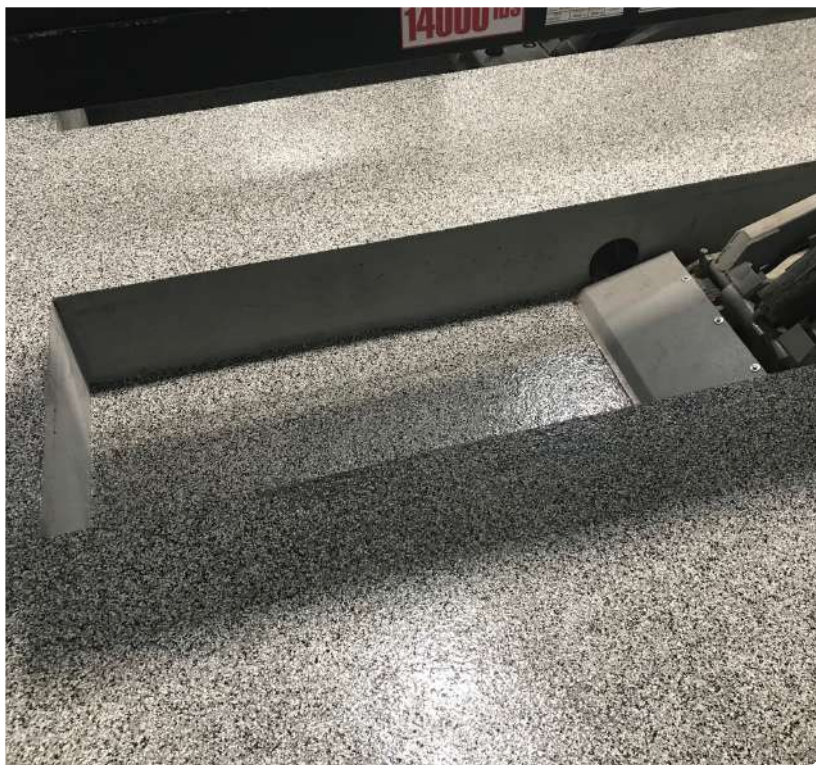
The broadcast coat had cured, and the excess flakes had been discarded. Again, the entire floor is swept and vacuumed to ensure that no small debris is left behind to cause problems in the final clear-coat.

Even the small spaces under the car-lifts got the flake finished epoxy. It's this attention to detail that set's the Weatherskin team apart from other installers.

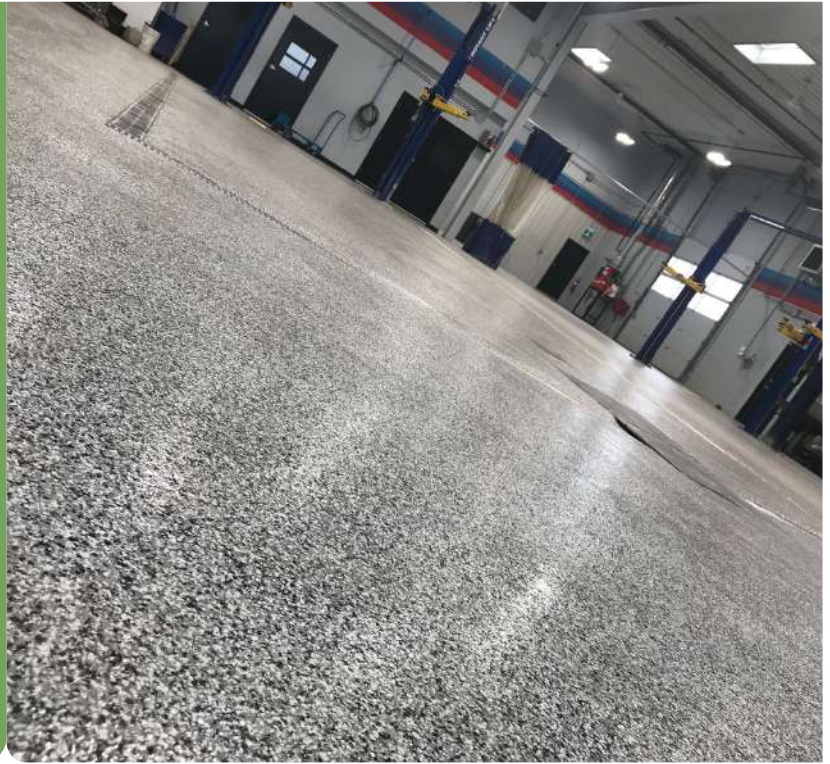
The glossy floor looks spotless and can now be easily washed with a pressure washer in a fraction of the time the old floor took to mop. The best part is that Weatherskin was more affordable than the original contractor and the job was done on time to be able to open the shop Monday morning. We will be gladly caring for this floor for the next 5 years as per our in-house service warranty.
